## Rome's Fountains

Protecting amazing masterpieces in the Eternal City

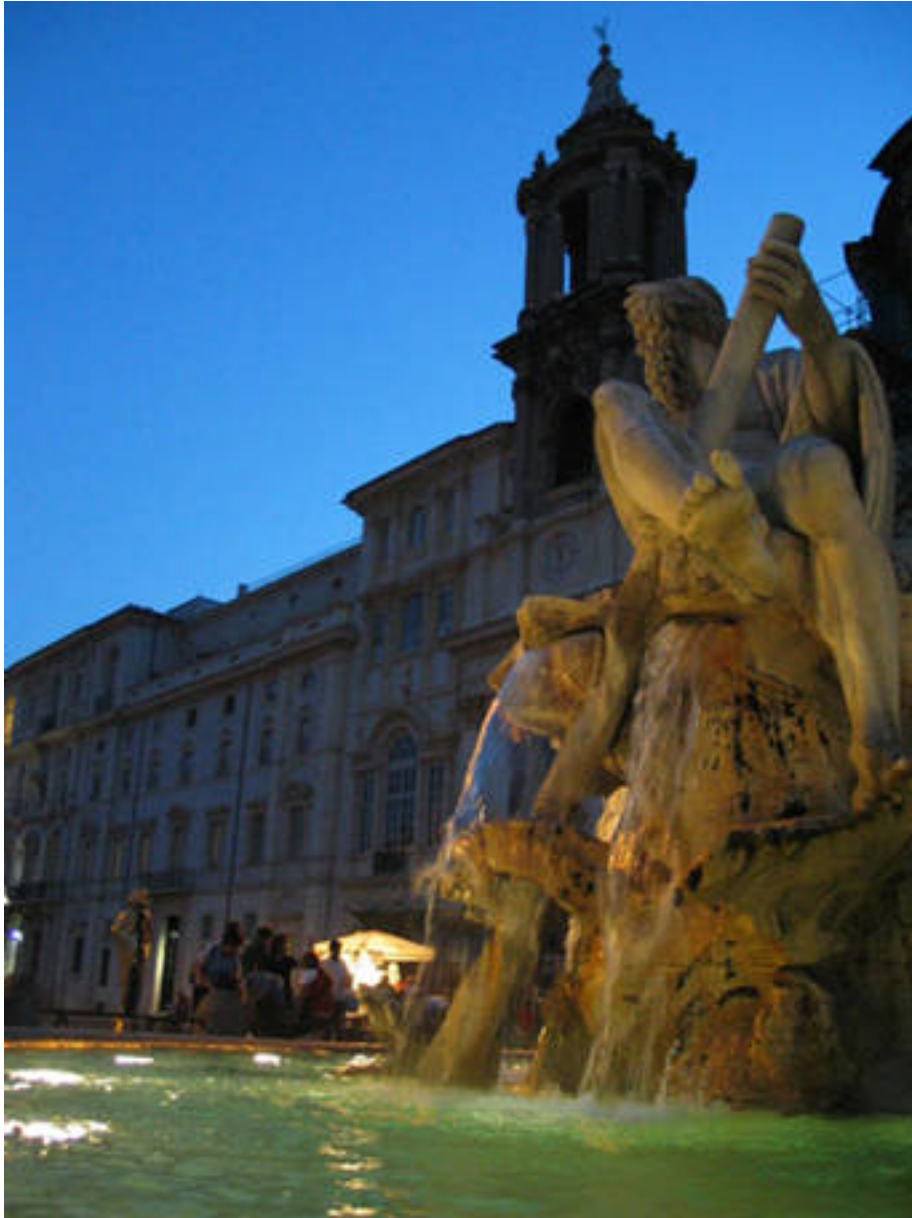
The hydraulic system was studied via endoscopy. In the portion where a figure represents the Ganges, photographs showed that in 1970 water emerged, as if over an invisible umbrella, from two narrow spouts and from two broad fissures that ejected sheets of water. "By 2006, water was escaping from the wrong place. The fountain was almost entirely blocked, and the mechanical action of the water then damaged an oar that was part of the group," said Pandolfi (see photo above).

For the carved portions of the Bernini fountain, sophisticated tools were put to use, such as a colorimeter and a video microscope. The extent of the erosion, and the depth of the fissures and elongated cracks in the four carved figures representing the rivers, were analyzed using ultrasound and laser scanning.
